Anderson, SC 29625 Tel (864) 646-TILE Fax (864) 646-2821 100 Clemson Research Blvd. TCNA TEST REPORT NUMBER: TCNA-035-16 Test #2

#### **TEST PROCEDURE:** ASTM C627: "A Standard Test Method for Evaluating Ceramic Floor Tile Installation Systems Using the Robinson-Type Floor Tester"

Identified by client as: "Tile Release System Test #2" **TEST SUBJECT MATERIAL:**

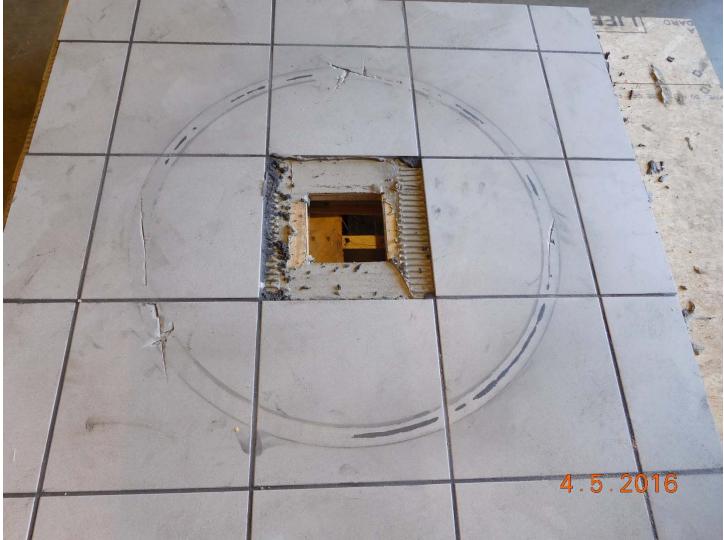
Image 1: Full assembly after testing

Cycle	Wheels	Weight (lb)	Observations
1		100	No visible damage, maximum deflection between the joists: 0.020"
2	Soft	200	No visible damage, maximum deflection between the joists: 0.042"
3	Rubber	300	No visible damage, maximum deflection between the joists: 0.073"
4		300	No visible damage, maximum deflection between the joists: 0.065"
5	Hard Rubber	100	No visible damage, maximum deflection between the joists: 0.030"
6		200	One broken tile, maximum deflection between the joists: 0.047"
7		300	Three additional broken tiles, maximum deflection between the joists:
			0.062"
8		300	
9		50	
10	Steel	100	
11		150	
12		200	
13		250	
14		300

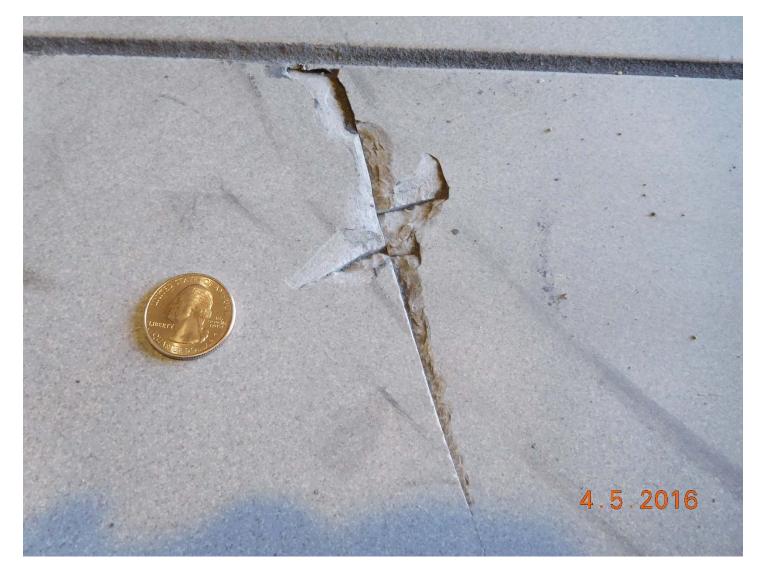
Image 2: Broken tile

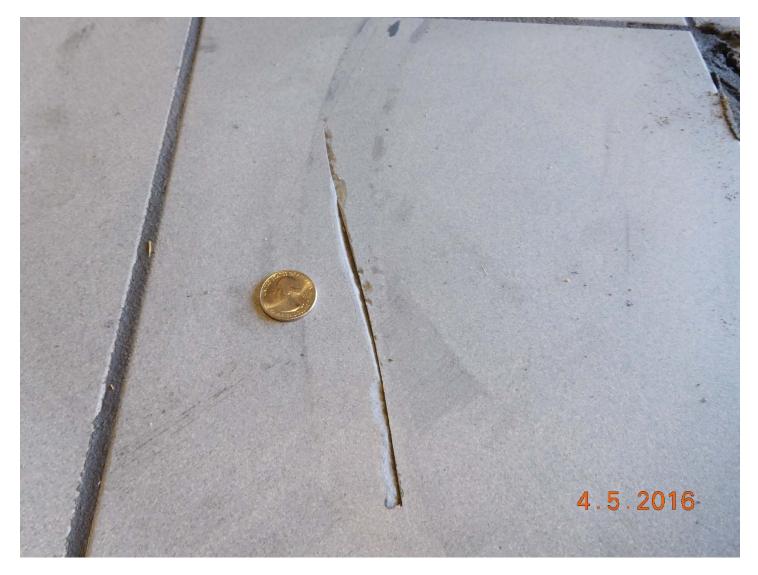
Image 3: Broken tile

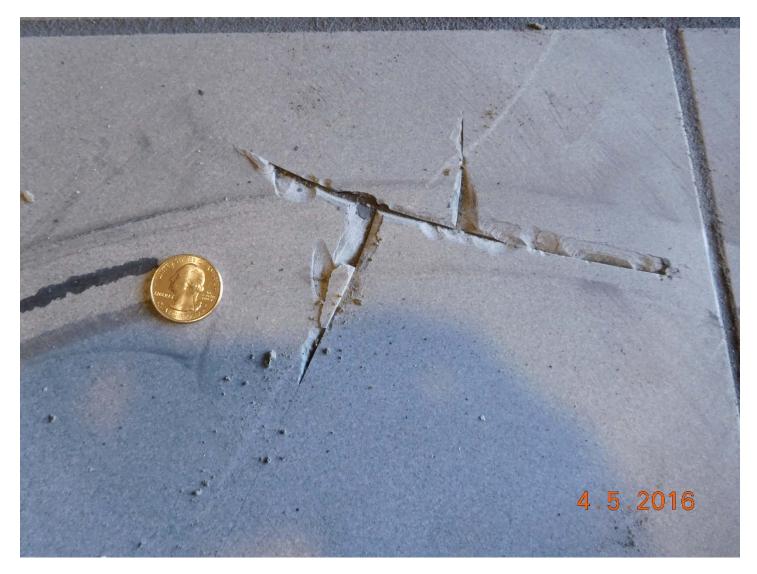
Image 4: Broken tile

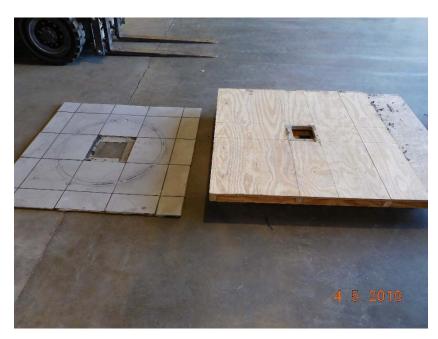
The client requested that a pry-bar and hammer be used to lift the tiles off the test pad and to record the time it took for removal and how many full pieces of tile were removed from the system. The tile removal took approximately 5 minutes and all pieces of tile were removed without breakage. Image below shows the tiles after removal from the test pad.
