TCNA TEST REPORT NUMBER: TCNA-527-14

TEST METHOD: ASTM C627: "A Standard Test Method for Evaluating Ceramic Floor Tile Installation Systems Using the Robinson-Type Floor Tester"

TEST SUBJECT MATERIAL: Identified by client as: "Ceramic Tile Release System"

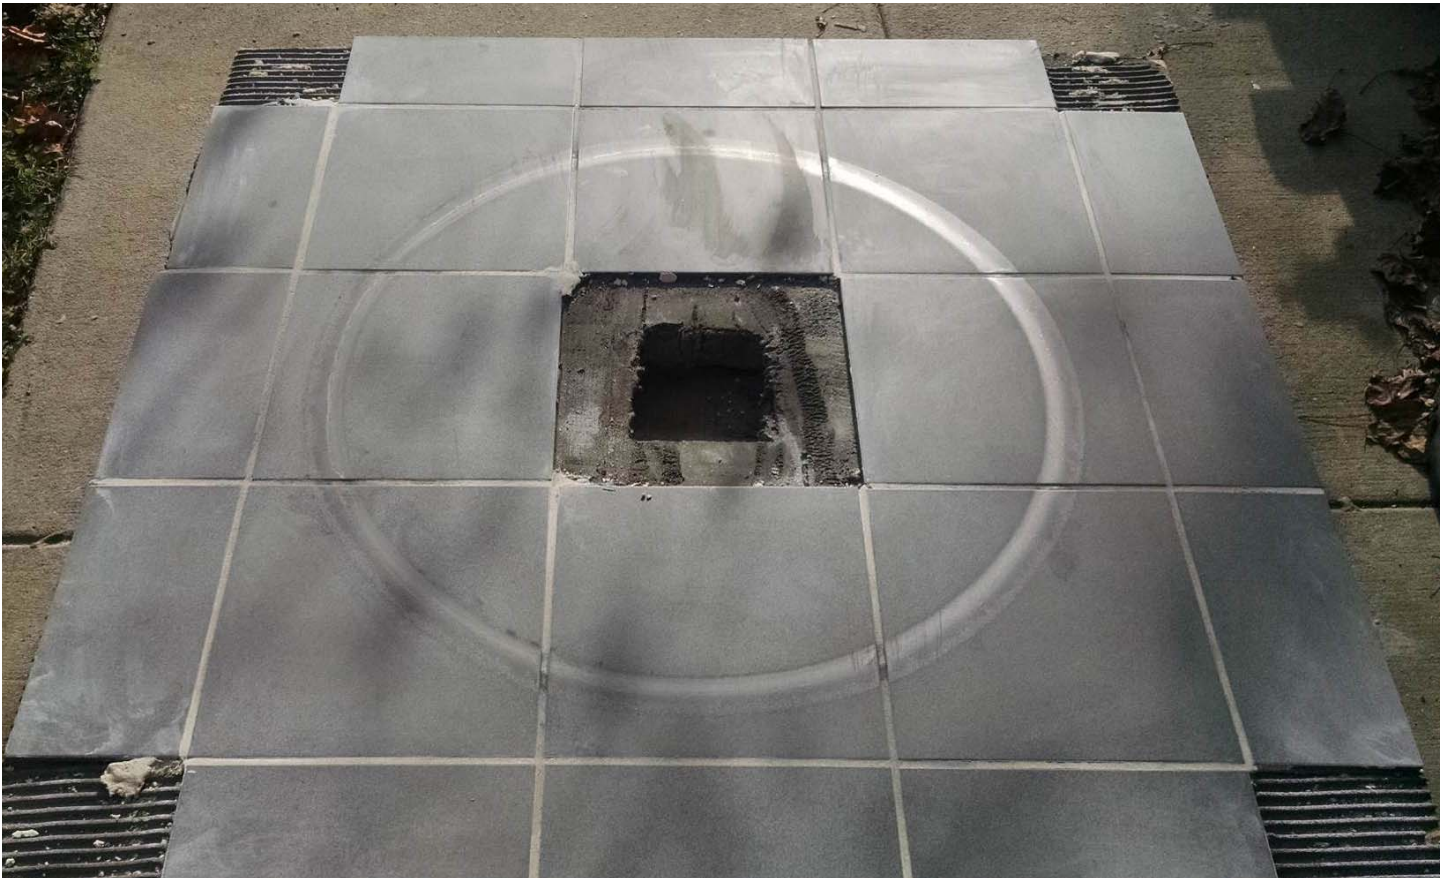
Image 1: Full Assembly showing 12" x 12" Crossville porcelain tiles after testing

The installation completed fourteen cycles with no evidence of damage to the tiles or grout joints. All evaluation criteria were based on 8 tiles and 8 grout joints in the wheel path of the Robinson-Type Floor Tester.

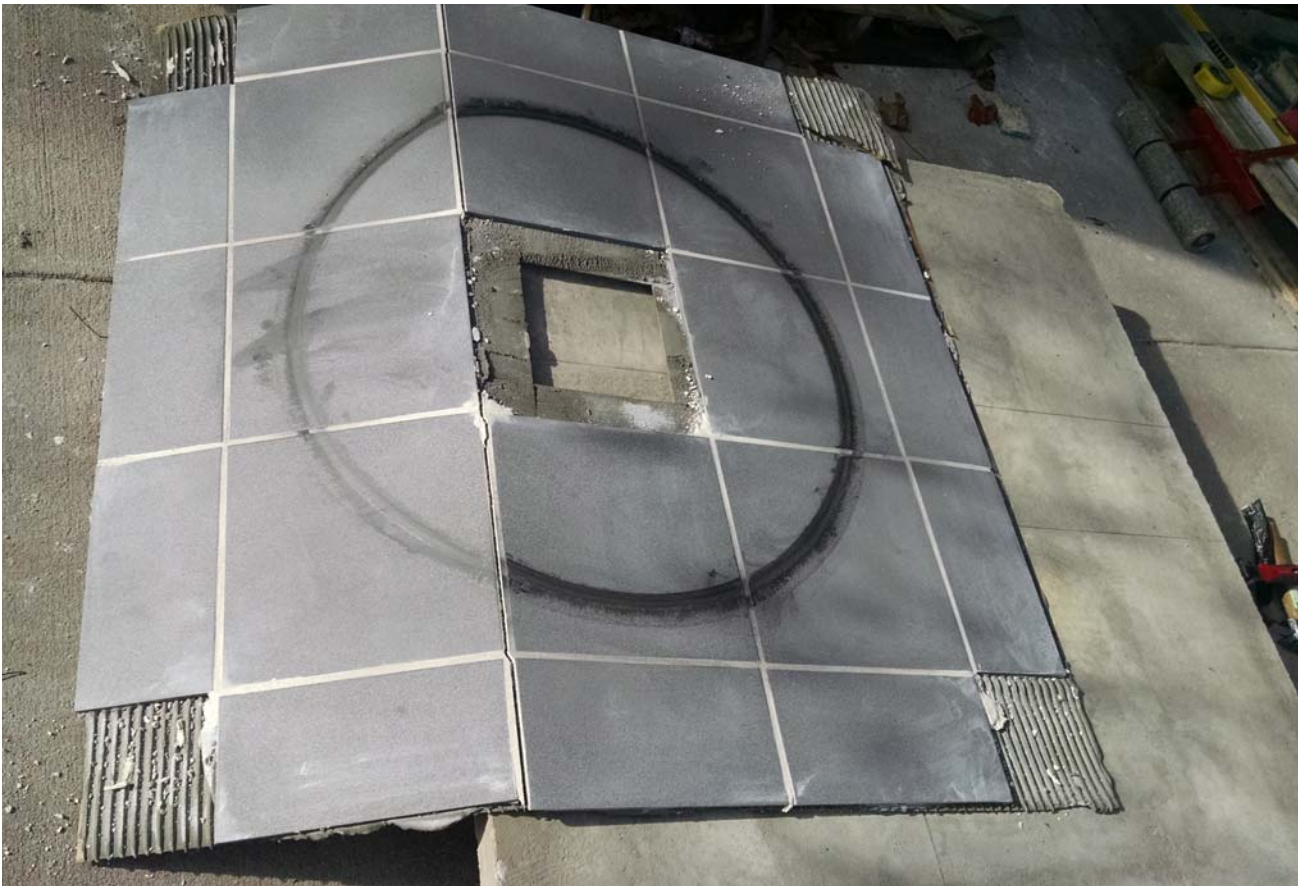
The following image shows the system after removal from the concrete substrate:

The client requested that all tiles be removed from the test pad after testing and that the following information be recorded: There were 8 full pieces and 12 half pieces of tile originally installed on the test pad and all were removed without cracking. The full system including the membrane was removed as one full unit. Some glue residue remained on the surface. The removal process took less than 1 minute to perform. It took an additional 5 minutes to scrape the visible adhesive from the concrete substrate but the substrate still felt tacky after removal.
