TCNA TEST REPORT NUMBER: TCNA-108-16

TEST REQUESTED BY: Nue Tile LLC

TEST PROCEDURE:ASTM C627: "A Standard Test Method for Evaluating Ceramic Floor TileInstallation Systems Using the Robinson-Type Floor Tester"

TEST SUBJECT MATERIAL: Identified by client as: "Tile Release System"

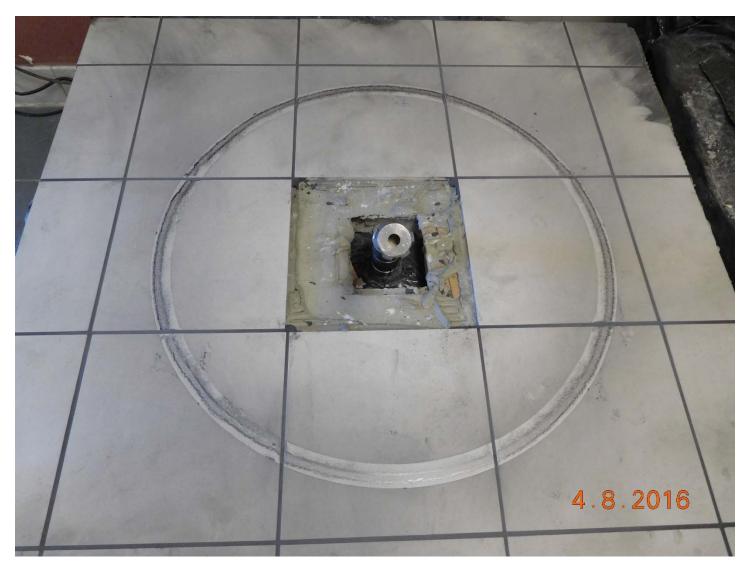
Image 1: Full assembly after testing

Cycle	Wheels	Weight (lb)	Observations
Cycle	wheels	e (/	
1		100	No visible damage
2	Soft	200	No visible damage
3	Rubber	300	No visible damage
4		300	No visible damage
5		100	No visible damage
6	Hard	200	No visible damage
7	Rubber	300	No visible damage
8		300	1 chipped tile
9		50	No additional damage
10		100	No additional damage
11	Steel	150	No additional damage
12	Sieel	200	No additional damage
13		250	No additional damage
14		300	1 additional chipped tile

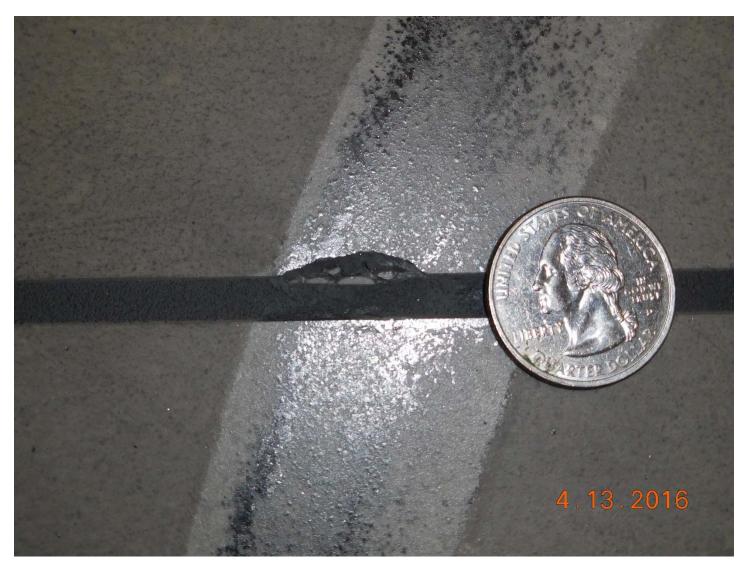
Image 2: Chipped tile

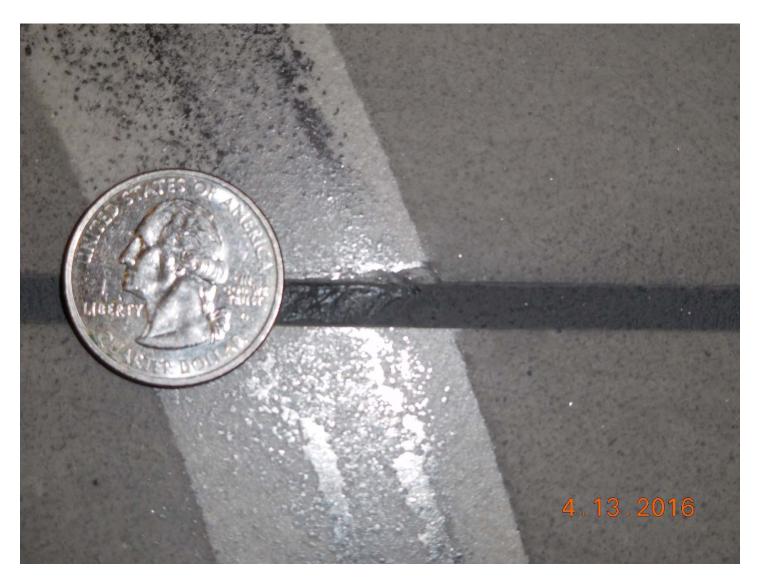
Image 3: Chipped tile
